Vermont's Slope Stability Challenges Highlight the Need for Resilient Solutions

BY: SHAWN KELLEY, PHD, PE ON SEPTEMBER 10, 2024

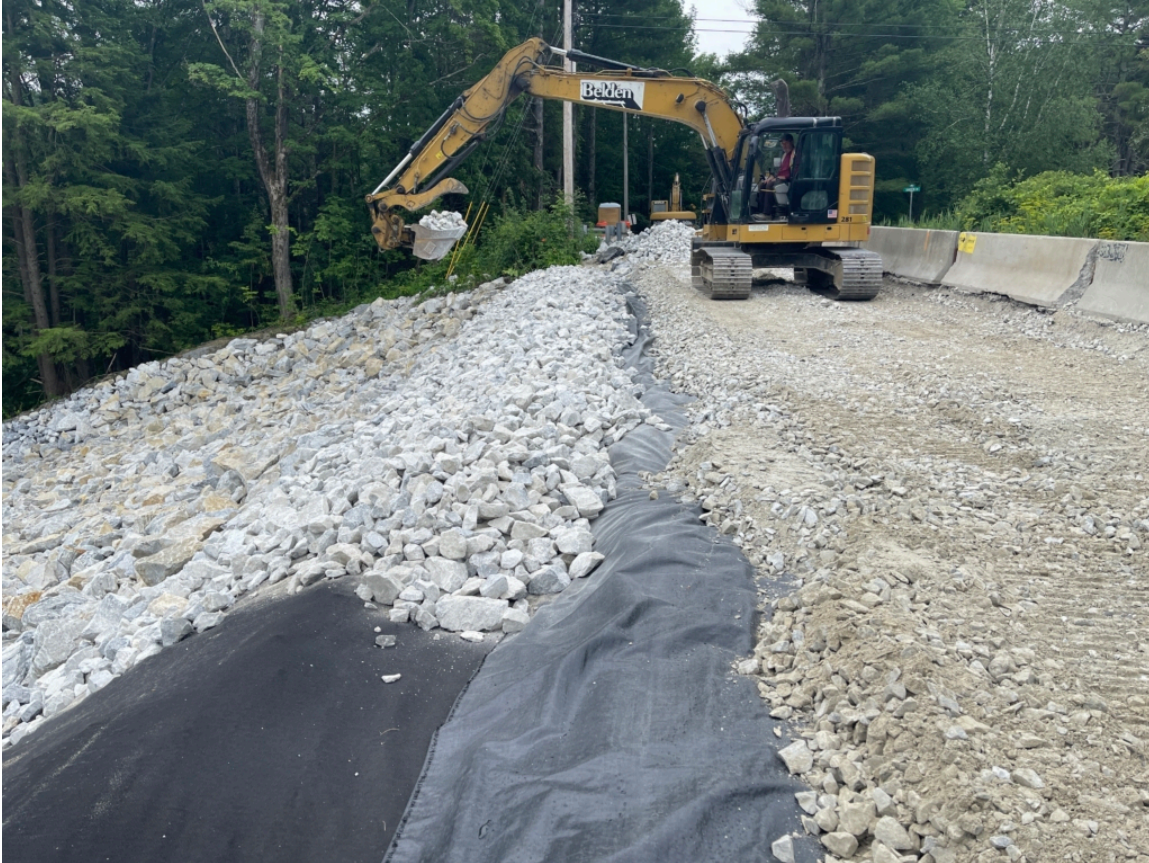
An example of a Level 3 resilient design is the **reconstruction of Dewey Avenue in West Rutland, VT.** Source: Sanborn, Head & Associates, Inc.

- **Level 3 – High-Risk Slopes**
 - **Resource Investment:** Very High
 - **Resiliency:** High
 - **Risk of Future Instability:** Low

Level 3 provides a more complex and resilient design. It is typically considered a “betterment” and provides a slope repair with the highest level of resiliency against future storms and damage, versus “in-kind” repairs which replace the slope with its original geometry.

For example, stone riprap with a stone buttress is constructed with additional design features that may include stormwater management (i.e., underdrains or additional culverts to divert surface water from the slope), reduction of driving forces that cause instability (i.e., the use of lightweight materials such as Geofoam, [Ultra-Lightweight Foamed Glass Aggregate \(UL-FGA\)](#), lightweight stone aggregate), and additional resisting forces (i.e., soil nails, toe walls, etc.).

This solution addresses future groundwater rises or big storm events by anticipating how water will impact the system and building defenses against future flooding. Because of this “betterment” designation, Level 3 solutions typically require substantial federal or state transportation funds.

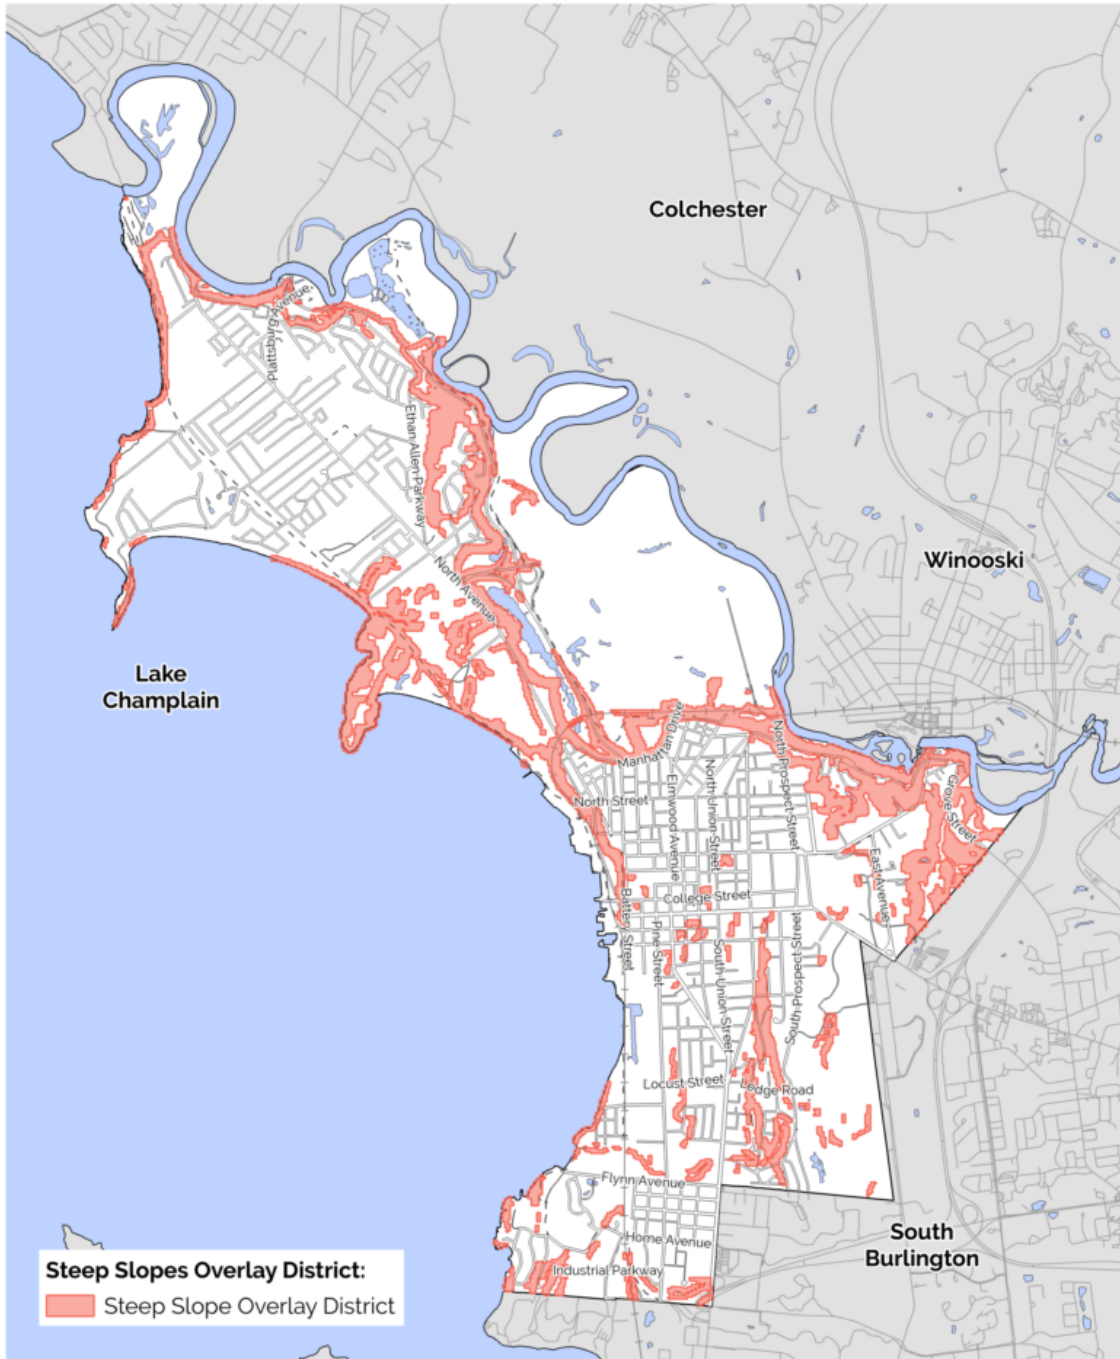
Steep Slopes Overlay District Map

Burlington Comprehensive Development Ordinance, Map 5.2.4-1
 Overlay district effective 10-12-2022 (from ZA-22-03)

Steep slopes overlay. Source: [City of Burlington, VT](#)

In Burlington, Vermont, the “**Comprehensive Development Ordinance**” addresses flood resilience and the fragility of steep slopes by designating specific, more flood-prone areas as “slope-weary.” The ordinance requires developers/homeowners to conduct a slope stability analysis before any new construction occurs. It also includes stricter requirements for new construction and substantial improvements in areas at risk of flooding, updated definitions, and clearer guidelines for floodplain management.
